NBS BUILDING SCIENCE SERIES 102

# The Thermal Performance of a Two-Bedroom Mobile Home

DEPARTMENT OF COMMERCE • NATIONAL BUREAU OF STANDARDS

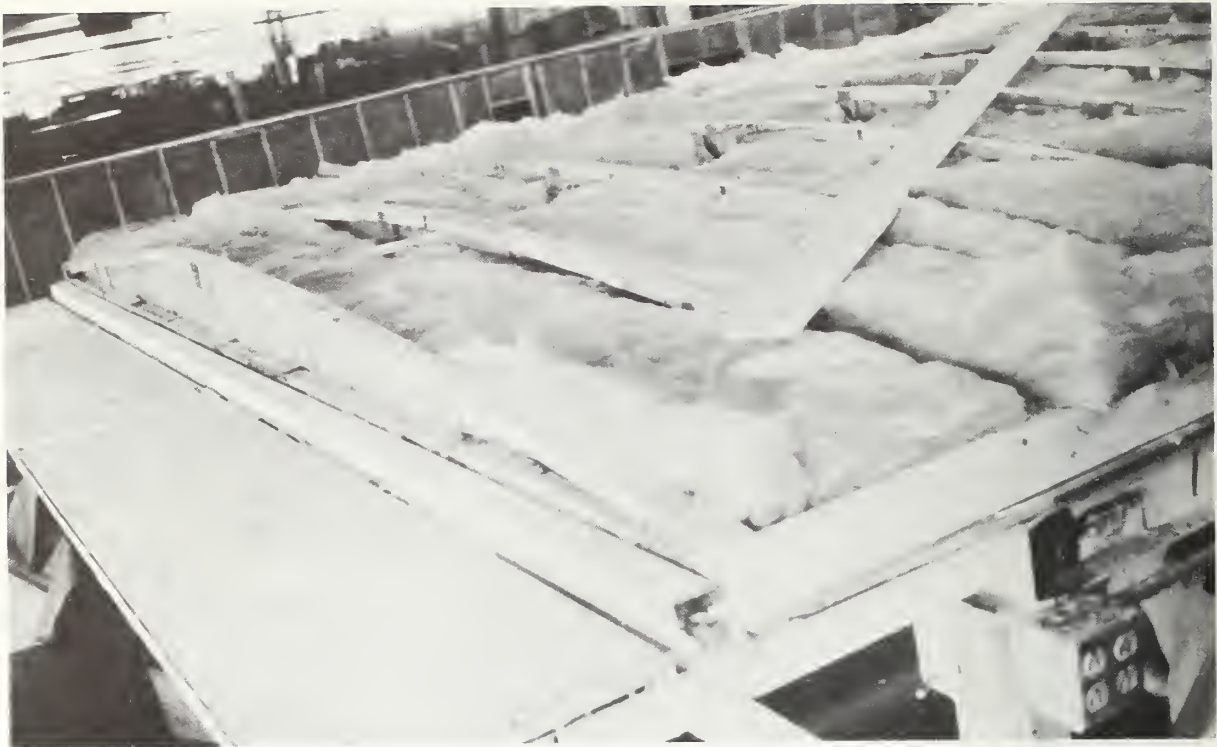
FIGURE 9. *Fabrication of roof section.*

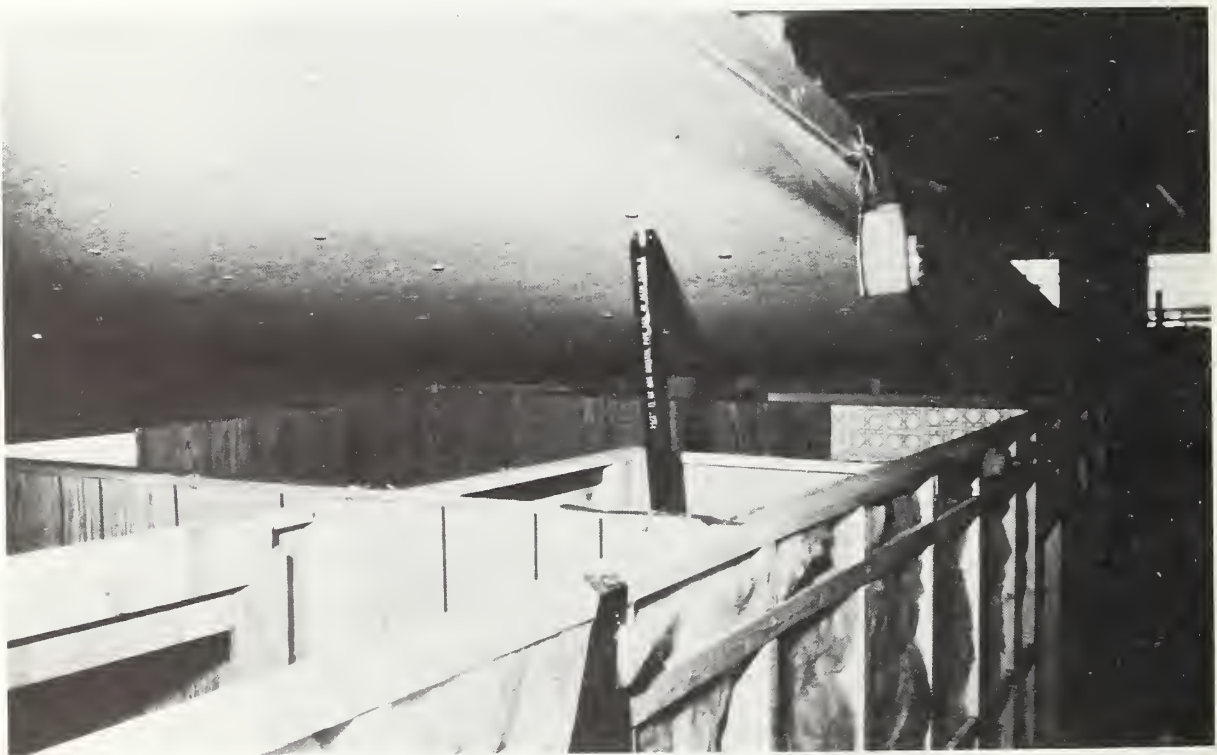
FIGURE 10. *Roof section being lowered onto walls.*

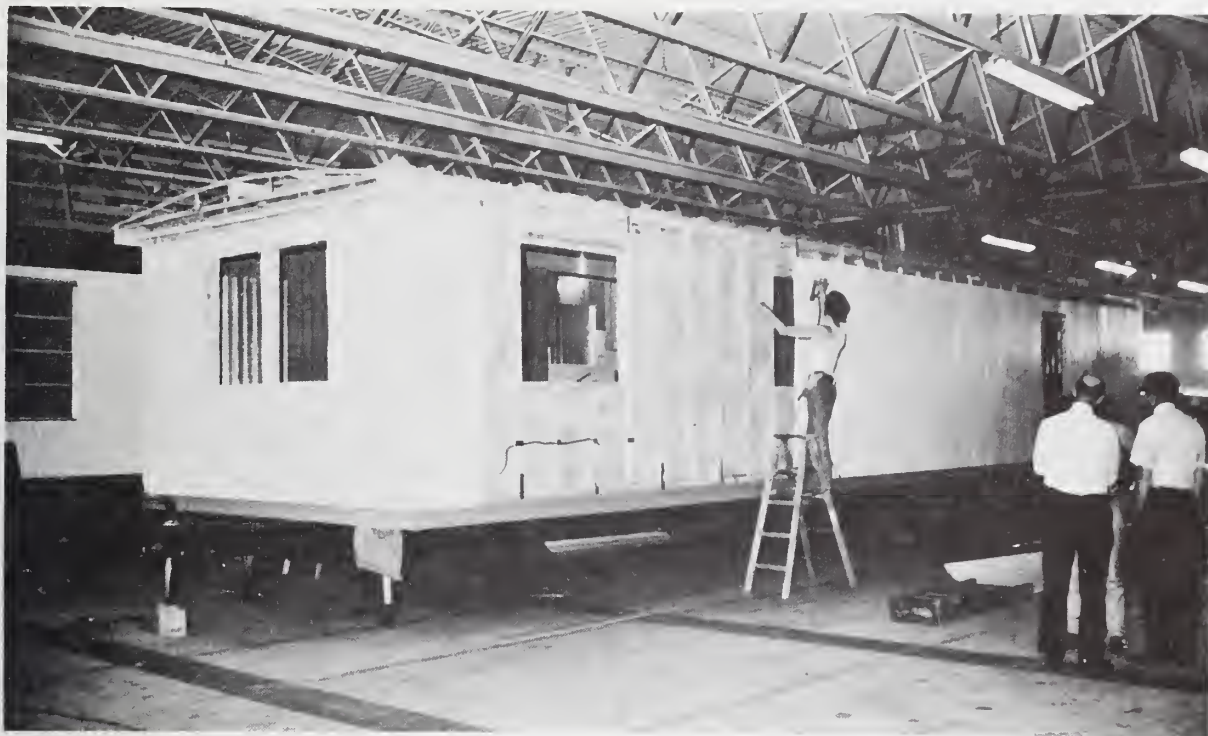
FIGURE 11. Installation of aluminum siding.

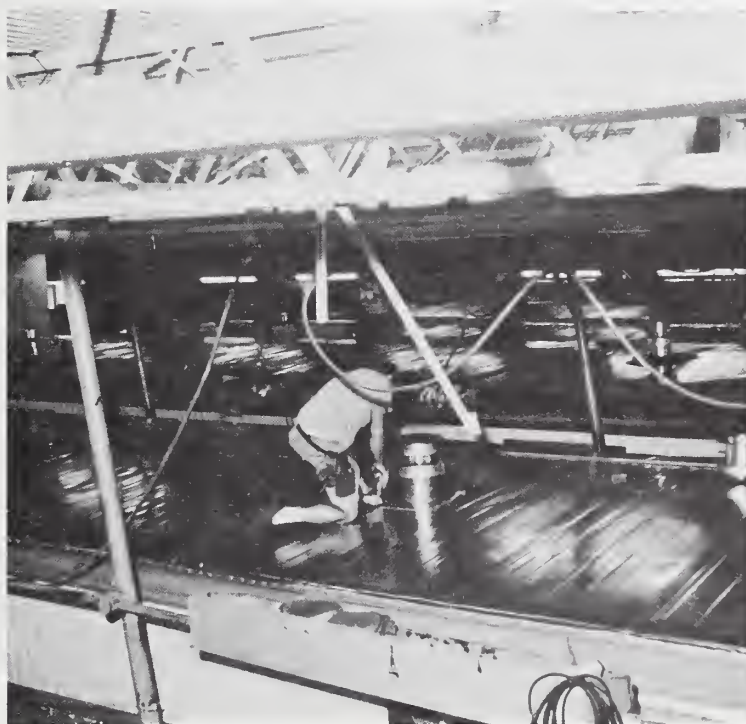
FIGURE 12. Installation of sheet metal roof.

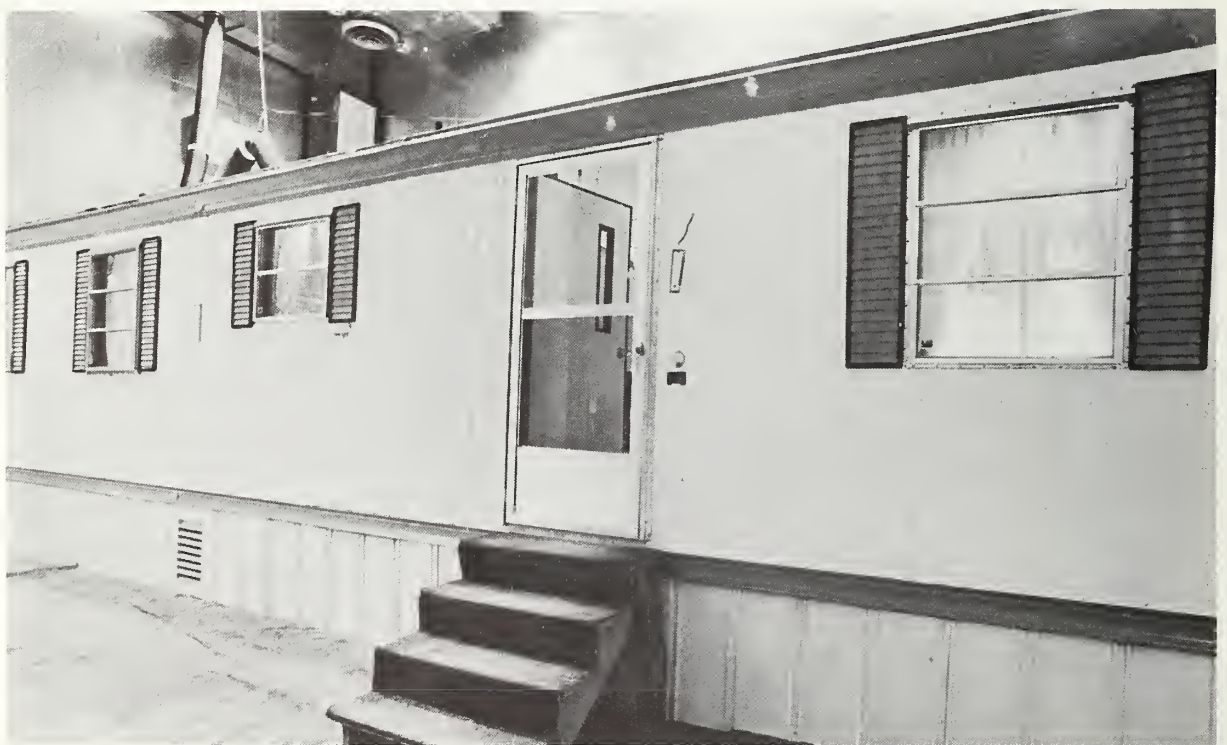
*FIGURE 14. Mobile home in environmental chamber.*

For expelling exhaust furnace flue gases, a 12-in diameter flexible hose was installed over the flue-gas stack located on the roof and connected to the laboratory outdoor exhaust system. The flexible hose installation is shown in figure 14.

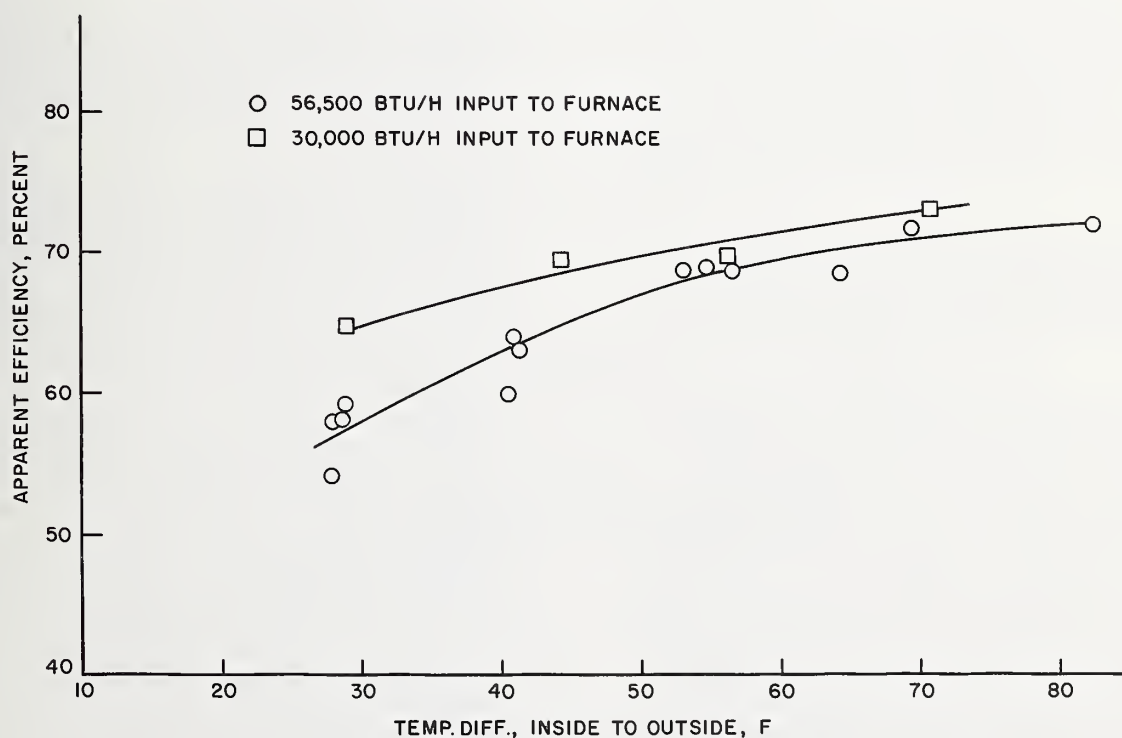
FIGURE 16. Apparent thermal efficiency of the original and modified furnace vs. inside-to-outside temperature difference.

where  $Q_e$  is determined from the relationships given above. These apparent efficiencies as a function of inside-to-outside temperature differences are shown in figure 16. These efficiencies were used to calculate net energy input to the mobile home for each test condition and compared with the predicted values.

The reduction in energy consumption can be attributed to the increased percent on-time shown in figure 17, resulting in decreased time for off-cycle stack losses. The apparent efficiencies shown in figure 16 were determined by comparing the gross gas furnace input to the electrical input under the same test conditions, assuming the electric furnace to be 100 percent efficient. At a temperature difference of 70 °F, both gas furnaces approach their continuous running efficiencies. At 30 °F temperature difference, the difference in efficiency is greater than 10 percent. These low-load operating conditions are common during the heating season.

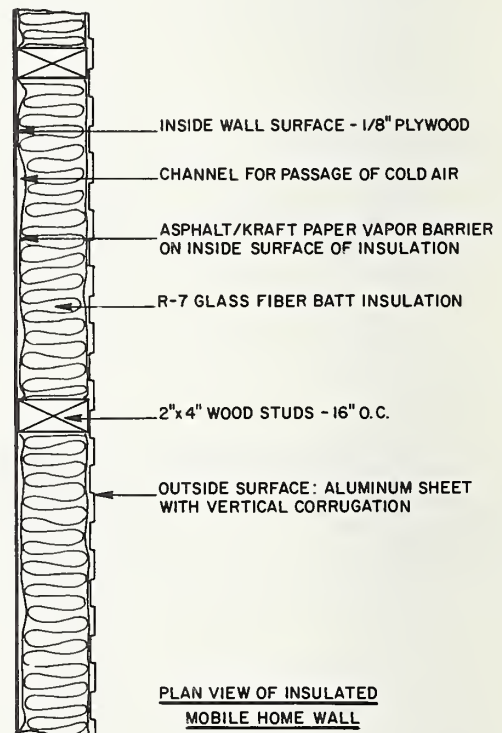
FIGURE 21. Plan view of insulated mobile home wall.

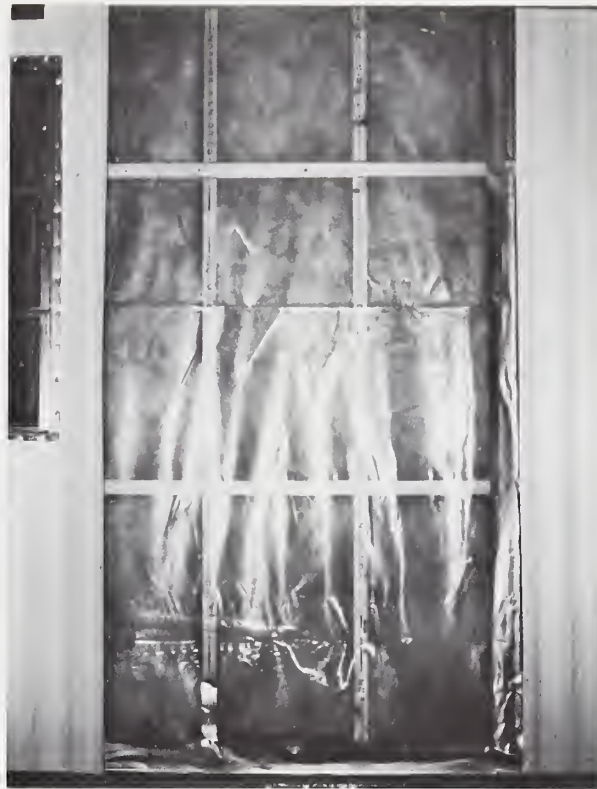
FIGURE 32. Six mil. polyethylene film used to seal insulation cavity from penetration of outside air.

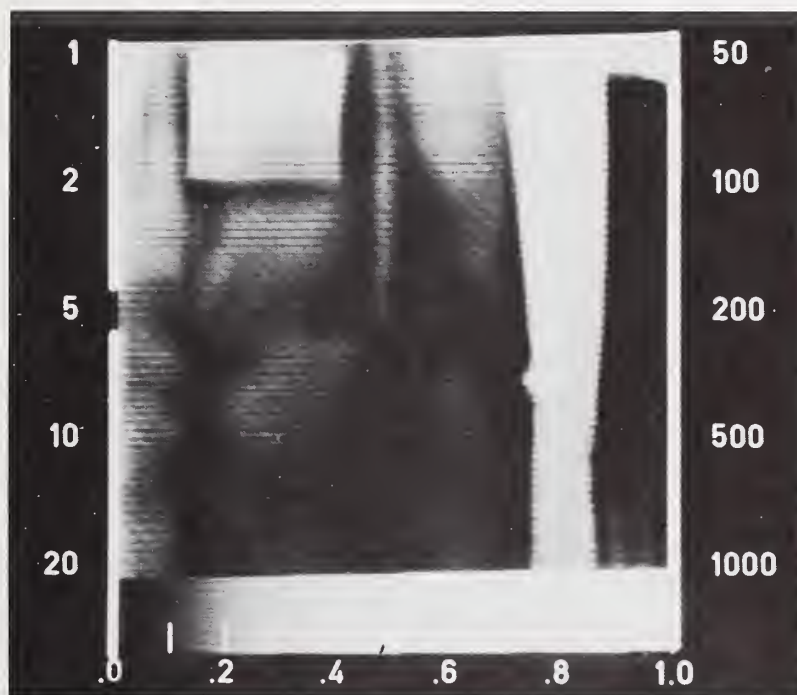
FIGURE 33. Thermograph of wall test area after sealing outside of insulation cavity with polyethylene film.

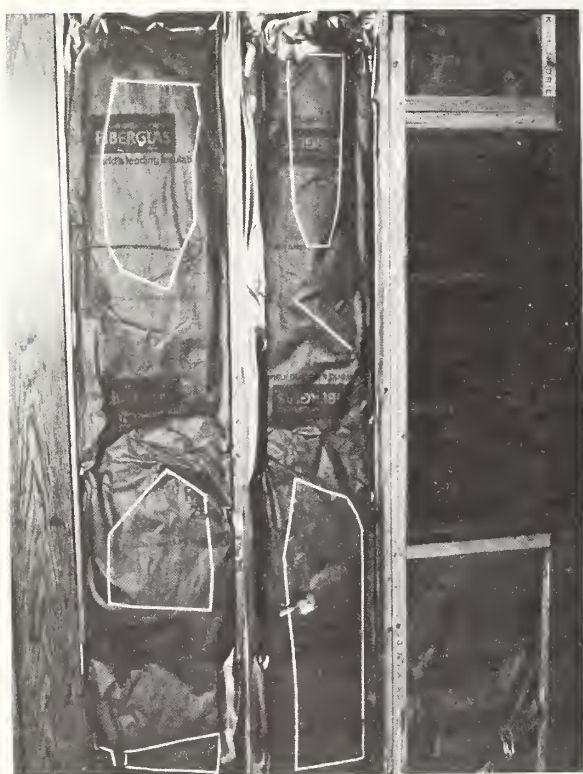
**FIGURE 34.** Inside of mobile home wall with paneling removed. Insulation vapor barrier has been sealed to stud with duct tape. White tape outline on surface of insulation outlines area in contact with back of paneling.

After taping the vapor barrier to adjacent studs, more thermographs were taken. The resulting thermal profiles showed that the inside sealing process had a

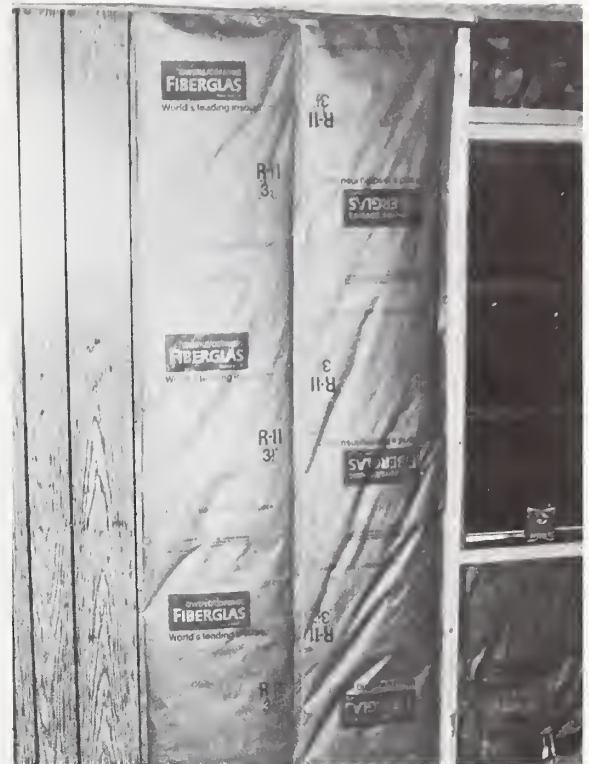
FIGURE 36. Same as figure 35 but with R-11 batt stapled neatly in place.

In both cases, thermographic and thermocouple observations revealed that the cold streaks were substantially eliminated with full batts. Without neat, mechanically-attached placement, some streaks did occur along the studs where the insulation was wrinkled due to stuffing the stapling flanges of the vapor barrier into the stud space, allowing air passage (see fig. 37). With neat attachment, cold streaking was eliminated and surface temperatures were very even, as shown in figure 38. As changes were made in the insulating system, inside-surface temperatures were recorded with the thermocouples located at A and B as shown in figure 39. These temperatures are shown in table 4.

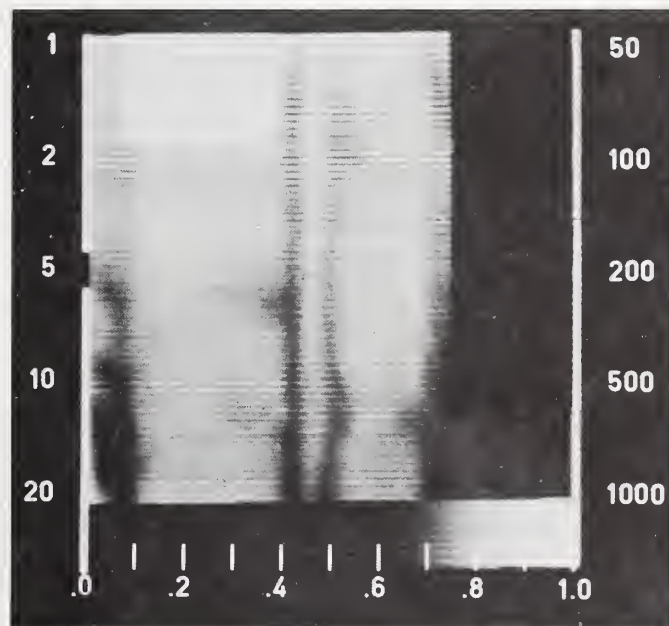
FIGURE 37. Interior thermograph after installing R-11 batt with friction fit. Note studs and cold streak caused by wrinkle in friction fit batt in narrow cavity.

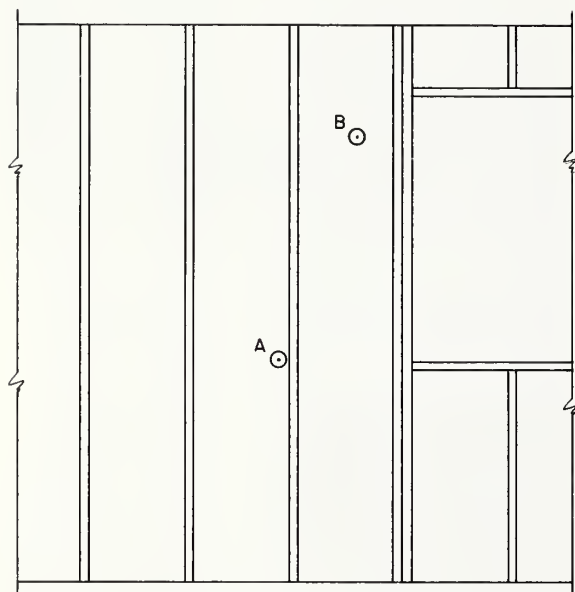
FIGURE 39. Thermocouple locations on inside of wall paneling. Temperature readings shown on table 4.

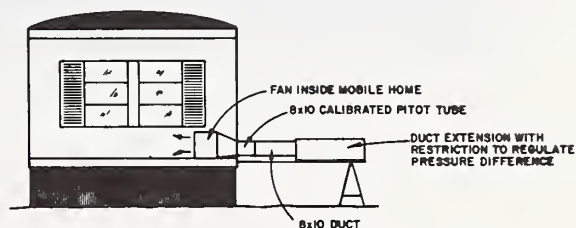
FIGURE 41. Equipment configuration for air leakage tests.

**Test method:** Refer to figure 41 for a diagram of the test equipment. An interior-mounted axial fan (fig. 42) was used to pressurize the mobile home and the total air flow was measured by means of a pitot static-air velocity measuring device located upstream of the fan (fig. 43). The differential pressure was maintained at a constant 0.20-in water gage by restricting the size of the open end of the duct extension as more and more leakage paths were blocked.

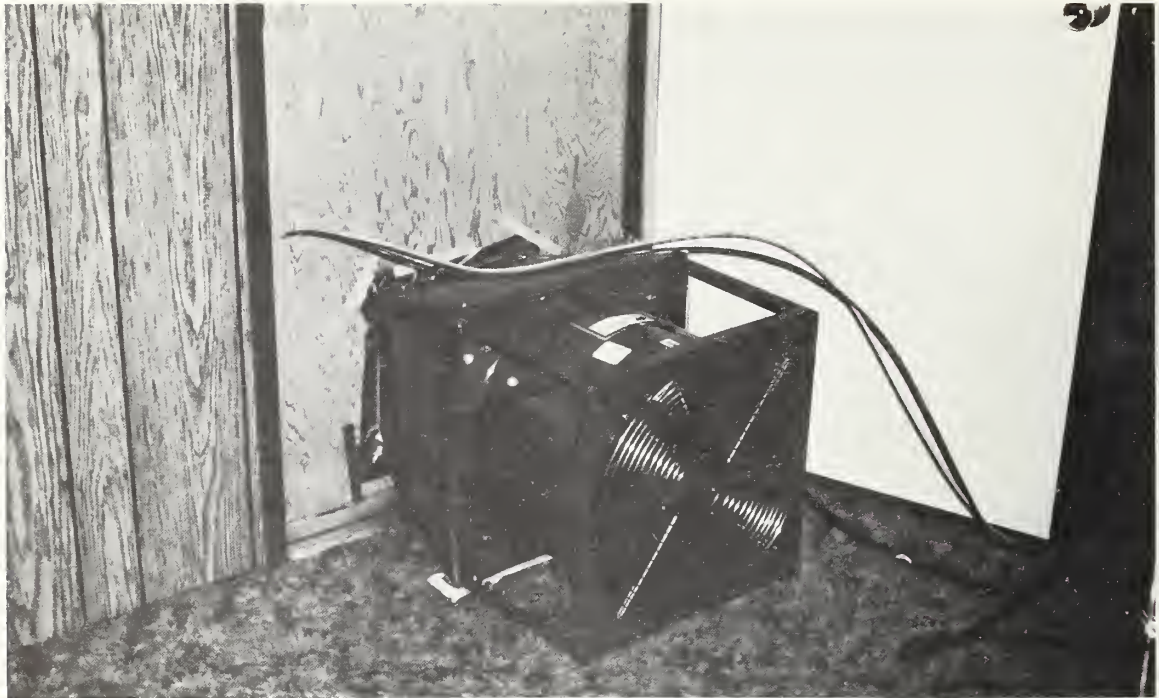
FIGURE 42. Vane axial fan mounted through sealed plywood partition at front entrance door opening.

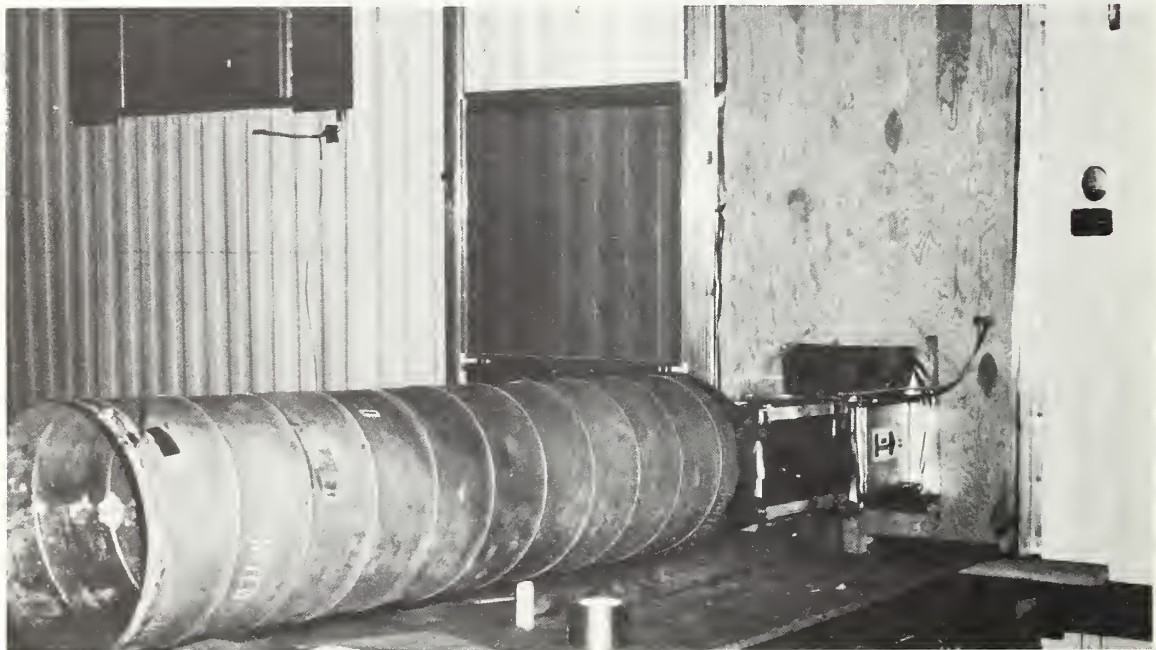
FIGURE 43. Pitot static air velocity measuring device located at plywood barrier. Duct leading to velocity measuring device was used to provide laminar flow of air over pitot static tubes.

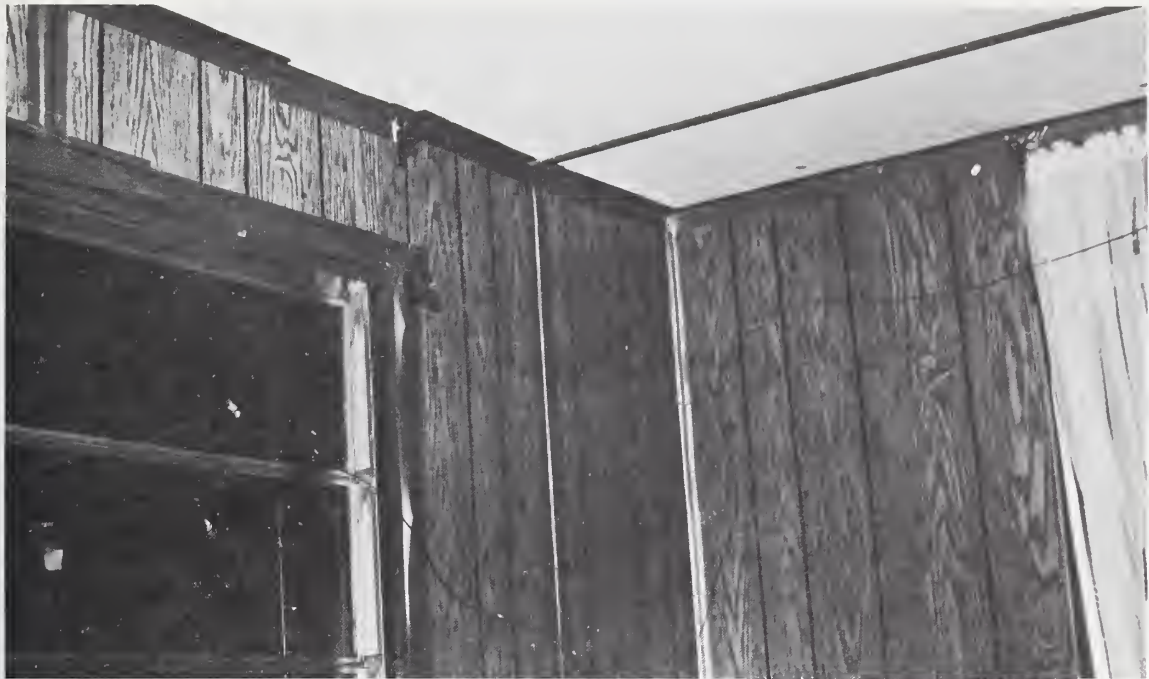
FIGURE 45. Panel side joints, wall corner joint, ceiling wall joints and window sealed with duct tape.

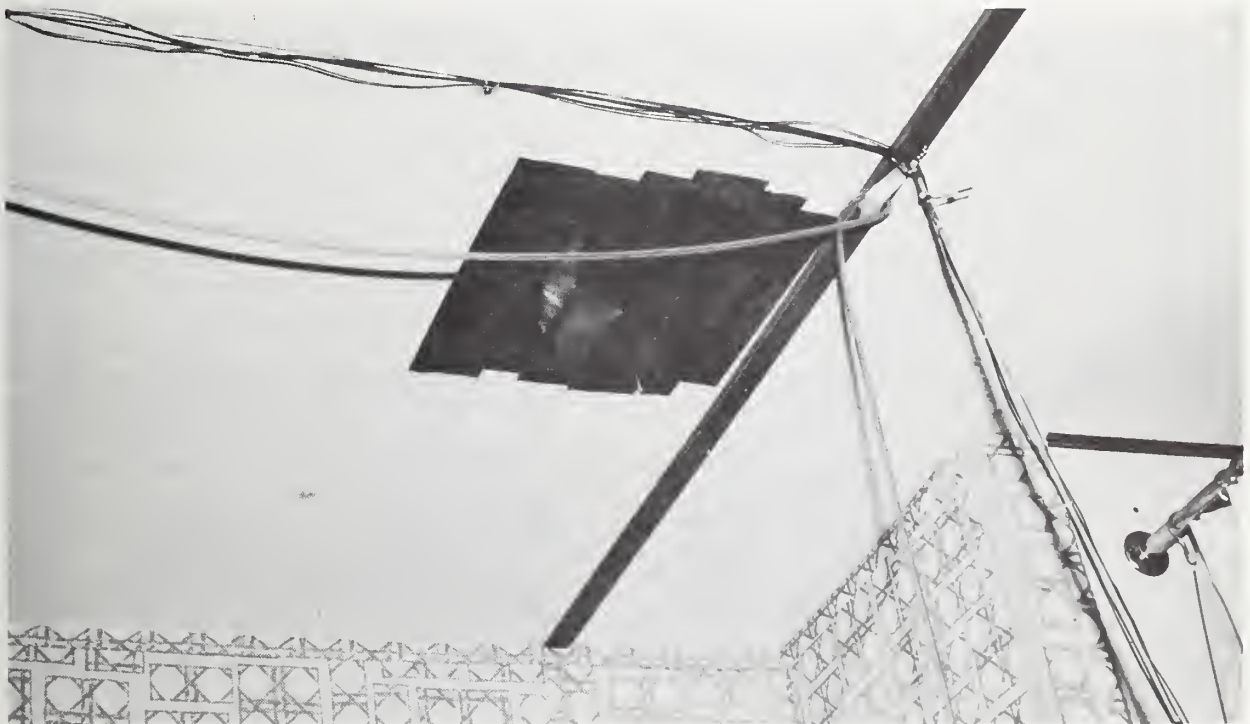
FIGURE 46. Bathroom exhaust fan sealed shut with duct tape.

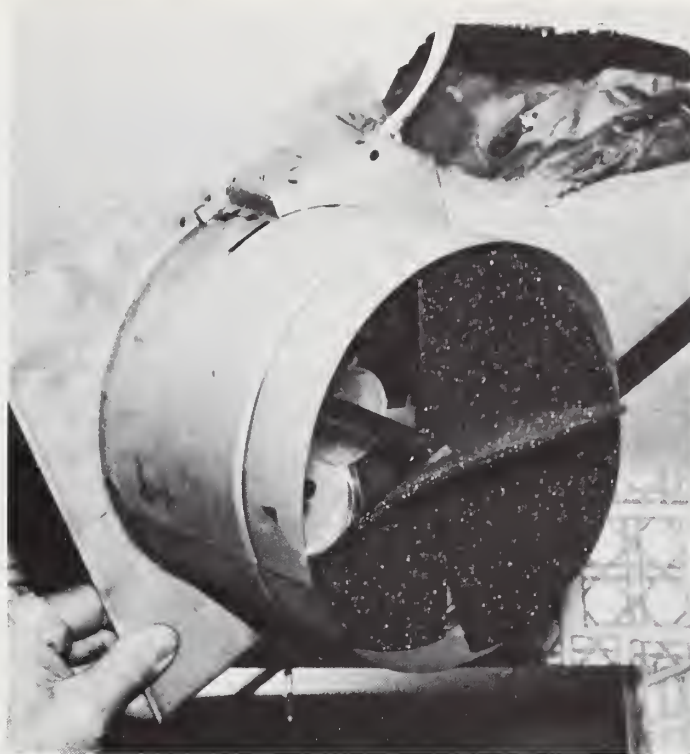
FIGURE 48. Bathroom exhaust fan with foam plastic backflow sealing flaps.

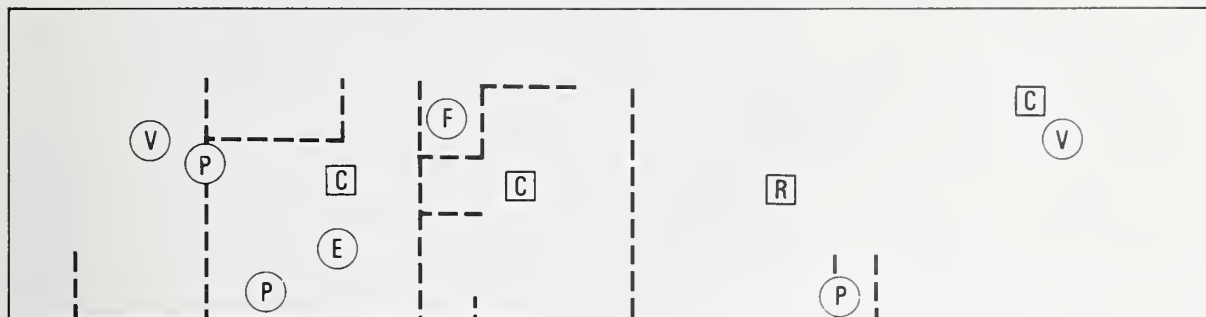
FIGURE 49. Plan view of roof.

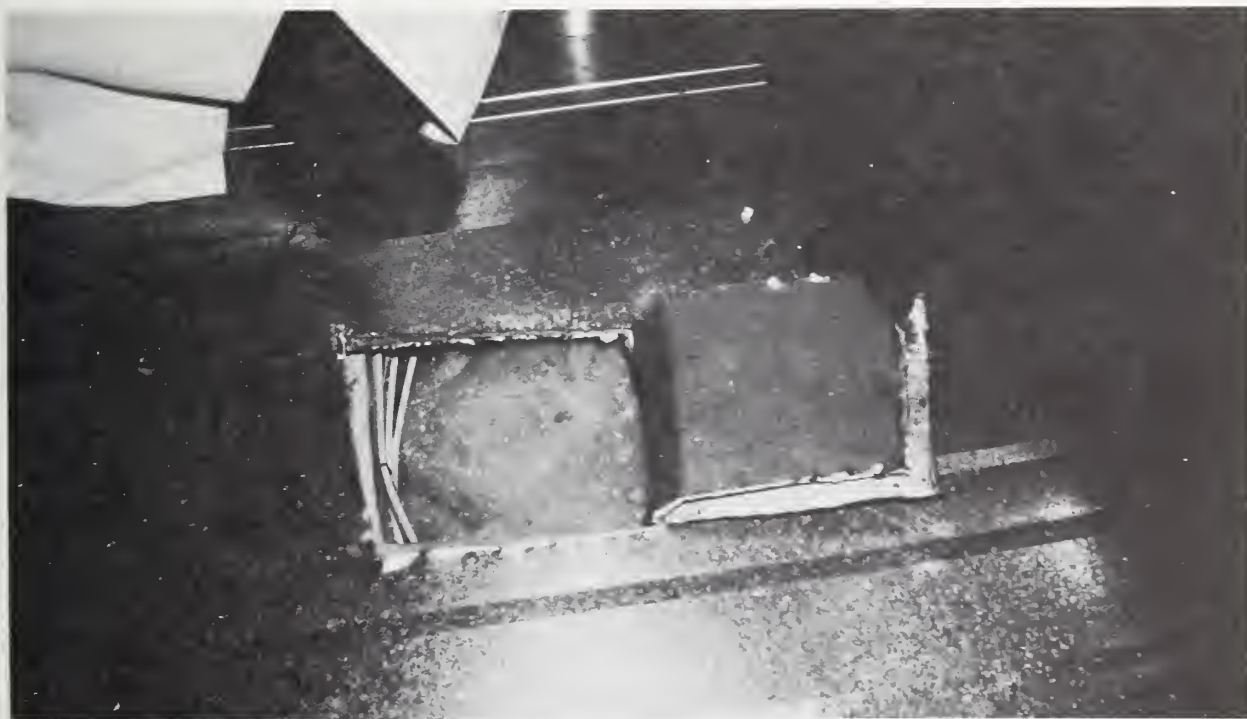
FIGURE 50. Roof test cut number 3 showing water and ice on bottom surface of sheathing and water droplets on top surface of roof insulation.

observed on the underside of the sheathing and water droplets covered the surface of the batt insulation. See figure 50.

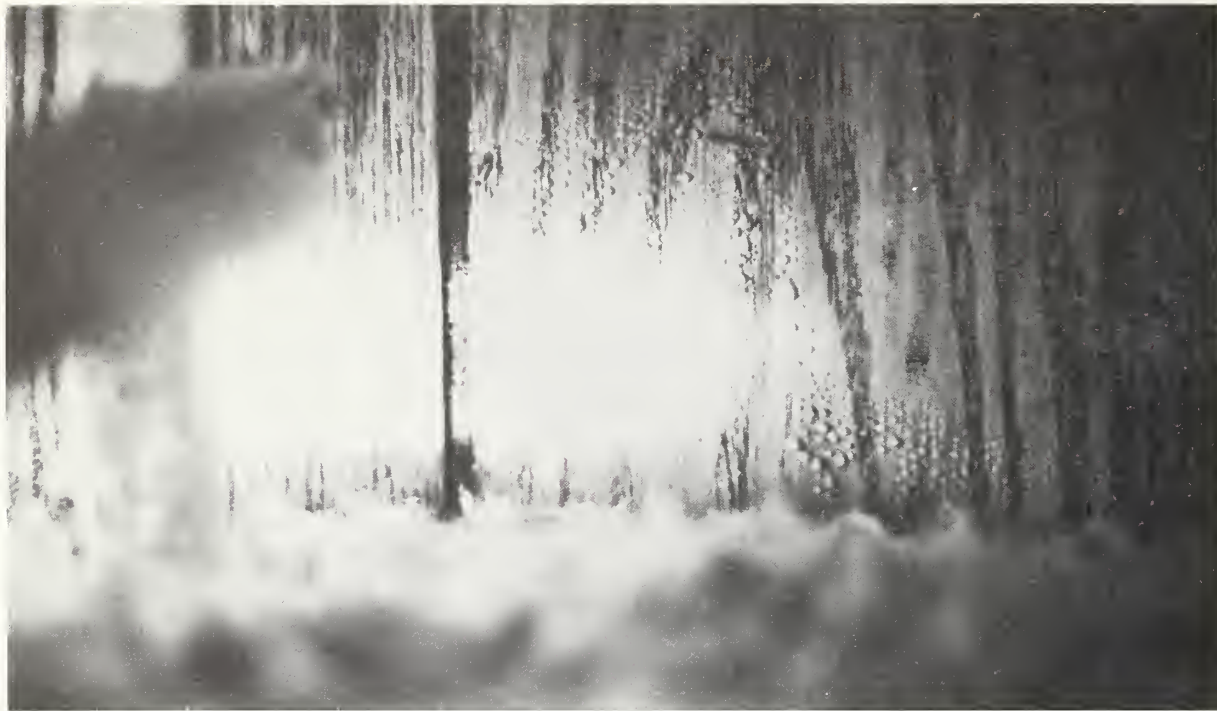
FIGURE 53. Surface moisture condensation at base of wall.
